Variation of Lower Passaic River Sediment Type with River Cross-Sectional Area

Lower Passaic River Restoration Project

Figure 11-4

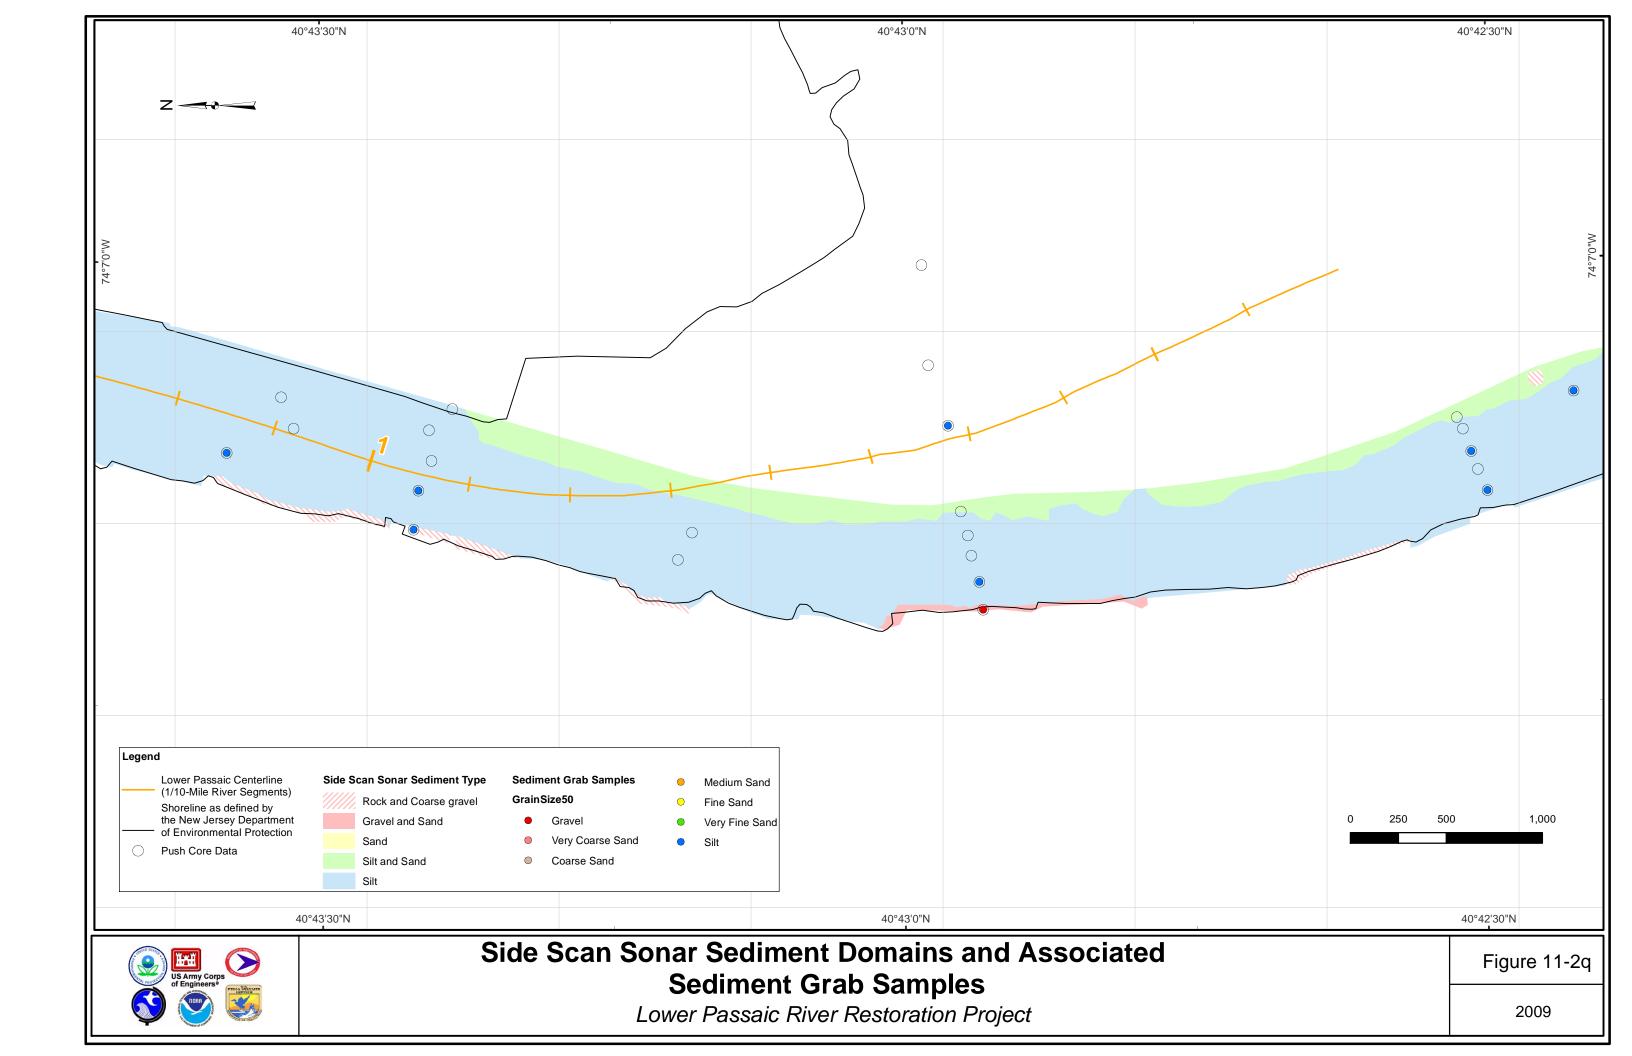
Highlights the change to --- a river cross sectional area of 3.500 square feet

Cross-sectional area estimated from 2004 bathymetric data surveyed by Rogers Survey, Inc. for USACE.

Sediment texture was evaluated based on data interpolated by Aqua Survey, Inc. using side-scan sonar images (Aqua Survey, Inc., 2006). Sediment texture data extends from RM0 to RM16.5.
